Technical Evaluation of the Gold King Mine Incident

San Juan County, Colorado

U.S. Department of the Interior
Bureau of Reclamation
Technical Service Center
Denver, Colorado

October 2015

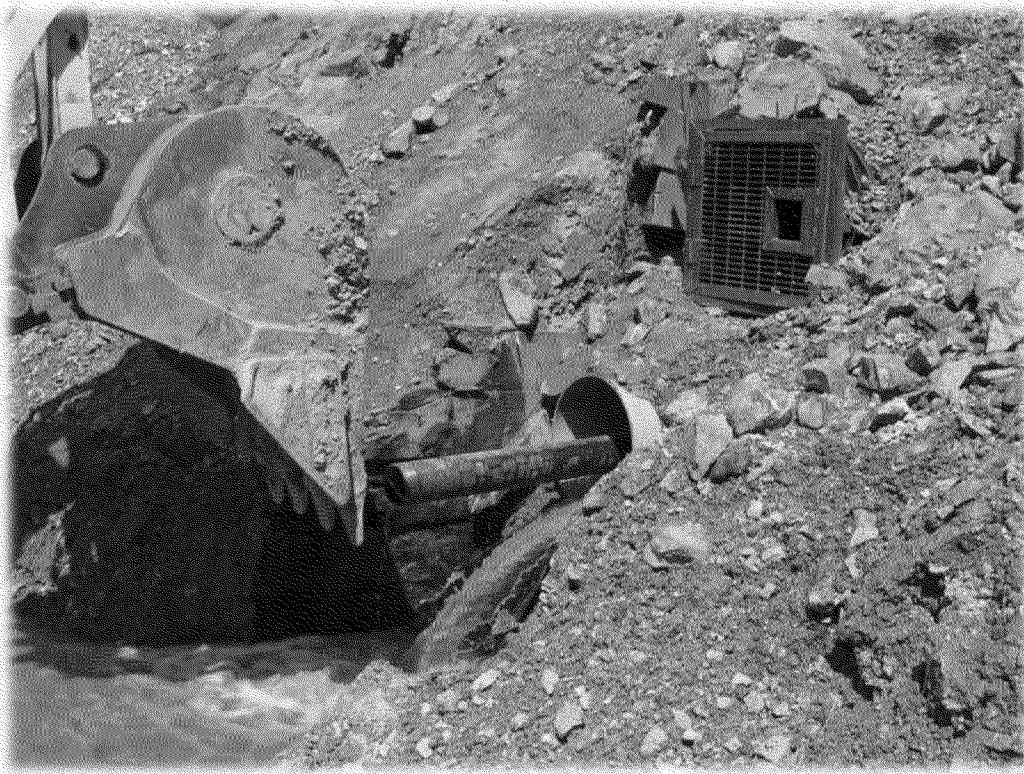
The mine drainage at the Gold King Level 7 Mine contains extremely high levels of metals and continues to flow between 150 and 300 gallons per minute. The mine drainage began after bulkheads were installed in the American Tunnel in 1995, which previously deep-drained the mining district. The mine drainage and the collapse at the Level 7 Old Portal continues to be of concern to the landowner, DRMS, and ARSG. A future project at the site may attempt to cooperatively open the Level 7 Old Portal in an effort to alleviate the potential for an unstable increase in mine pool head within the Gold King workings.

Gold King Level 7 Old Portal with well-point installed through the drain pipe. This portal may be re-opened in a future project to help stabilize the mine drainage and prevent future increases in mine pool head.

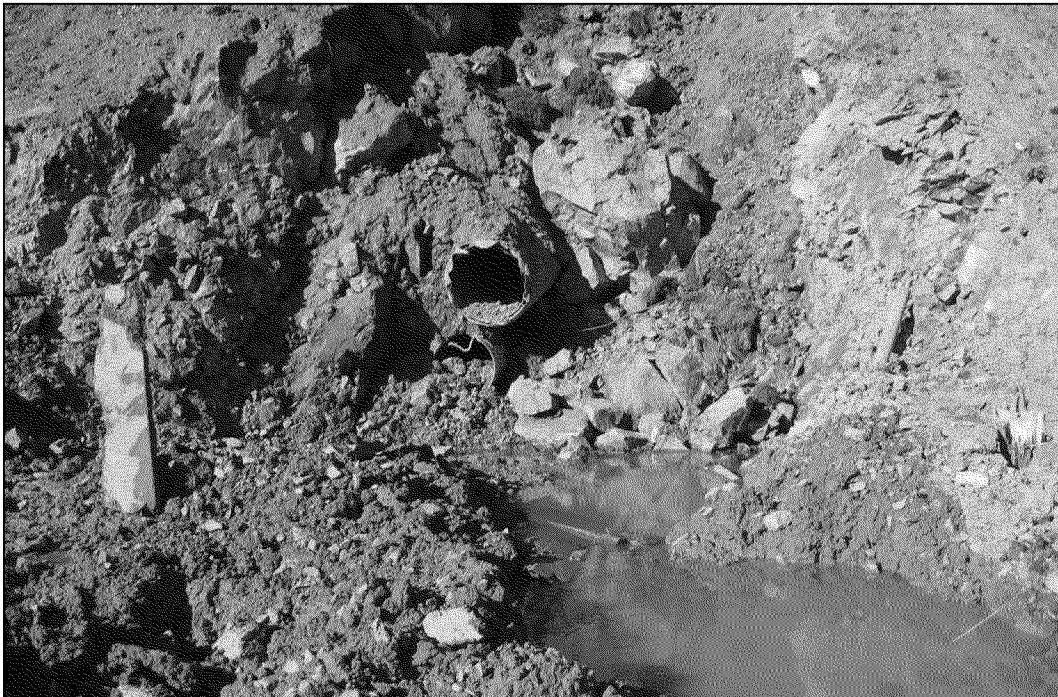
On September 11, 2014, excavations were performed to remove the metal grating and portions of the two pipes installed in 2009. As the excavation progressed down through the fill, seepage appeared (figures 25 through 27). The work stopped when EPA, DRMS, and others observed that in addition to the seepage from the base of the fill, additional seepage was now flowing from higher up on the face of the backfill. Because the excavation had a lip, the seepage ponded at a level equivalent in elevation to about 4 feet below the top of the adit. It was reportedly concluded by those onsite that there was 6 feet of water impounded in the mine (Way, 2014b). A small settling pond was installed at the base of the waste-rock dump to remove sediment from the mine water. The pond was not large enough to treat and settle what was believed to be 6 feet of impounded water. Therefore, the project was put on hold until the following year.

Figure 26.—Photograph showing the excavation of the Gold King Mine New Adit portal on September 11, 2014, taken shortly after the photograph in figure 23 (photograph from EPA project files).

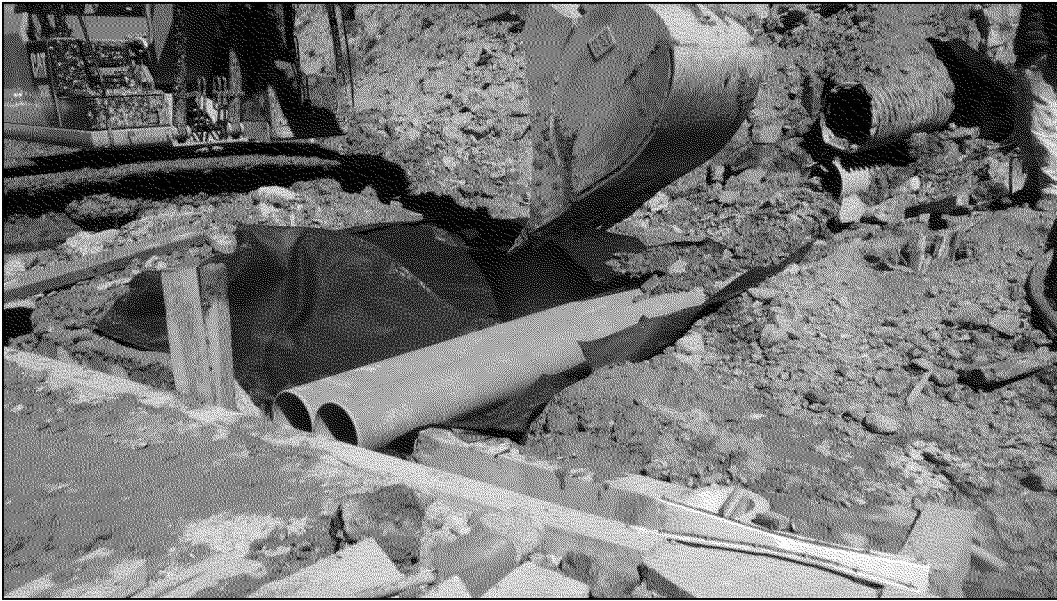
Figure 28.—Photograph taken on September 11, 2014, showing the installation of two new 2-foot-diameter drainage pipes. An entrance slot has been cut into the concrete trough for the pipes to discharge into (photograph from EPA project files).

Because they had torn out most of the drain and observation pipes installed by DRMS in 2009, EPA decided to install two new drain pipes surrounded by gravel and a geotextile as a temporary measure. The new pipes were laid at a different angle than the 2009 installation. The side of the concrete trough had to be cut open to accommodate the new drain pipes (figure 28).

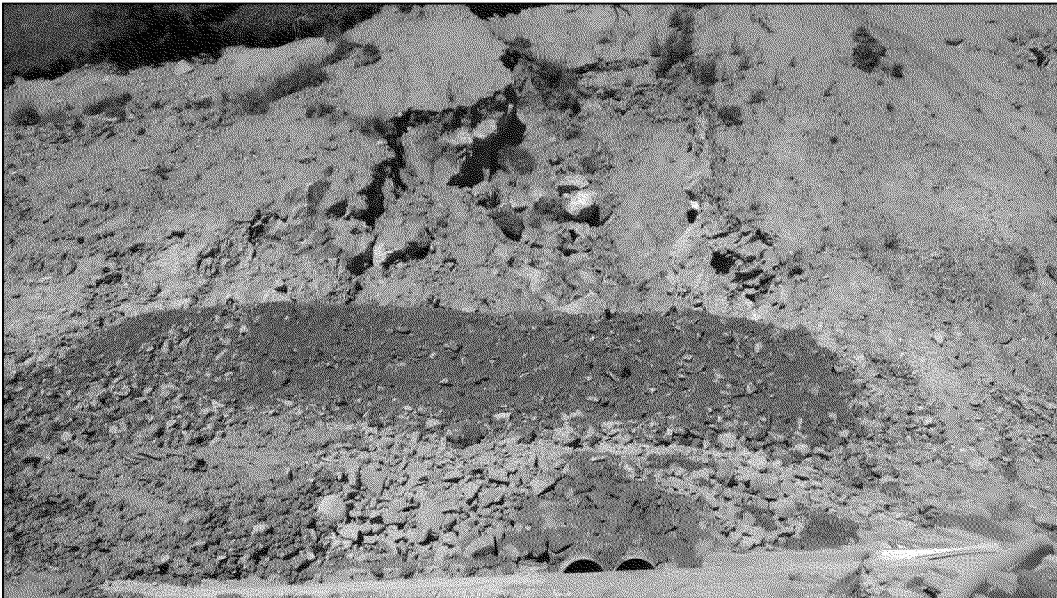
Figure 29.—Gold King Mine Level 7 New Adit as it appeared on September 12, 2014, when EPA completed placing backfill over the two new drain pipes. Note that a steep slope was left in place in the mountainside above the drain pipe installation (photograph from EPA project files).

The pipes were covered with gravel. The geotextile was wrapped around the gravel to prevent infiltration of backfill to maintain a pervious zone around the pipes. The geotextile was then covered with backfill. In order to prevent erosion of the backfill soil into the concrete trough, a layer of fast setting concrete was placed over the backfill slope adjacent to the trough (figures 29 and 30).

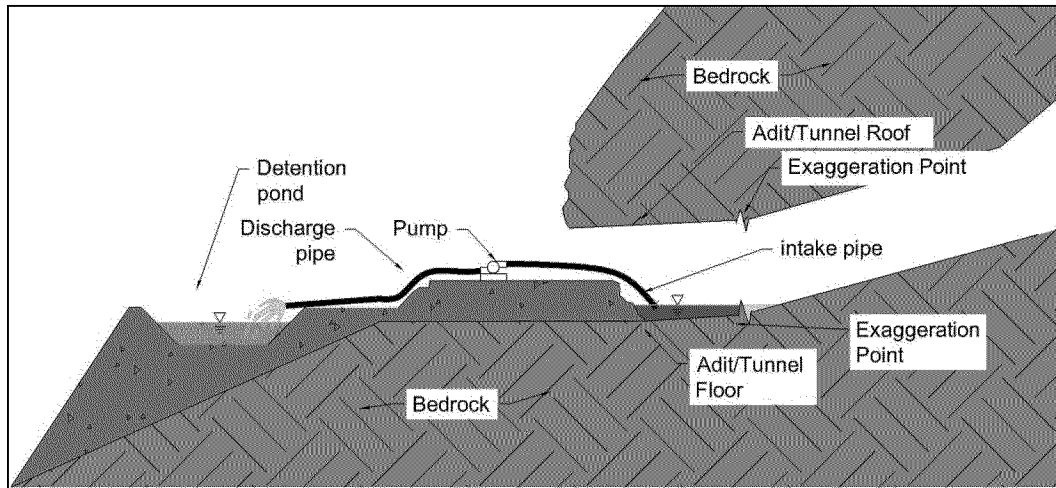
Figure 45.—Cross-section illustration showing step 5 of the plan (not to scale). As the water inside the mine is drawn down by pumping, additional fill from the blockage is excavated and the pump is repositioned to a lower level on the remaining fill. This step is repeated until all the impounded water and the remaining fill is removed; this will establish access to an open adit with the flow freely draining out.

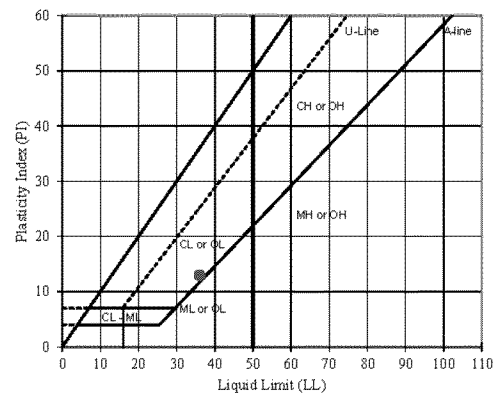
PROJECT NAME: USBR/Lab Testing - 2014/CO
SAMPLE ID: #2
TYPE: Pail

Sieve Analysis (Initial Separation on No. 4 Sieve)	Particle Size		Description	Percentage
	Sieve	(mm)		
	3-inch	75.0		100.0
	1.5-inch	37.5		95.6
	1-inch	25.0	Coarse Gravel	23.12
	3/4-inch	19.0		76.9
	3/8-inch	9.5		52.8
	#4	4.8	Fine Gravel	39.15
	#10	2.00	Coarse Sand	9.02
	#20	0.85	Medium Sand	9.84
	#40	0.43		18.9
	#60	0.25		16.5
	#100	0.15	Fine Sand	6.63
	#200	0.075	Silt or Clay Fines	12.24

Visual Description:
Clayey gravel with sand, yellowish brown, moist

LL	PL	PI
36	23	13
